Voyager VOM74MM Mirror Monitor Recall Repair Instructions – Sprinters and Promasters

Brief History

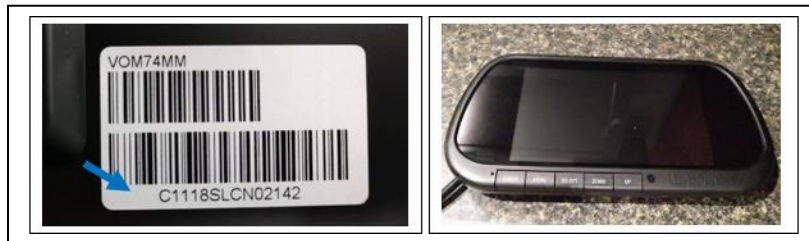
Verify the Voyager VOM74MM monitor model by looking at the label on the back of the mirror monitor. If the monitor Serial Number (on label) starts with an A, B, or C the monitor **MUST** be replaced **AND** Field Fix Kit harness removed. SN must start with D, E, or F.

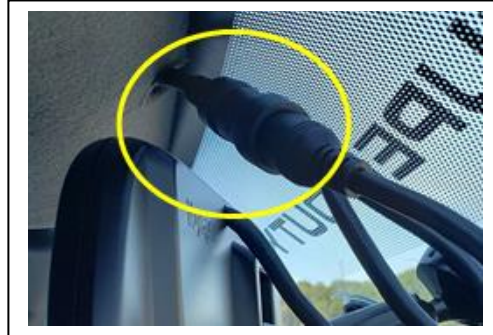
NOTE: This connector needs to be found and disconnected to remove Voyager Mirror Monitor. It is usually in the headliner

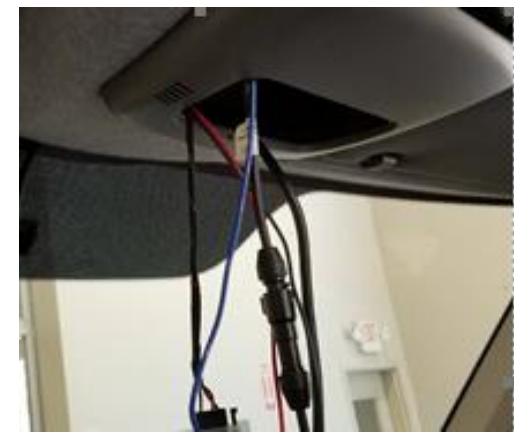
Step 1 - To gain access to the Connector, the Dome Light cover needs to be removed.

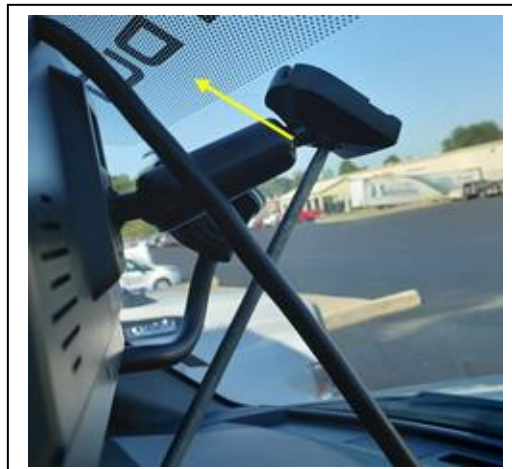
Step 2 - To remove the Monitor from the windshield mount, use a Phillips screwdriver to loosen the screw on the mirror mount stem. Once loose, slide the monitor up to remove it from the mount.

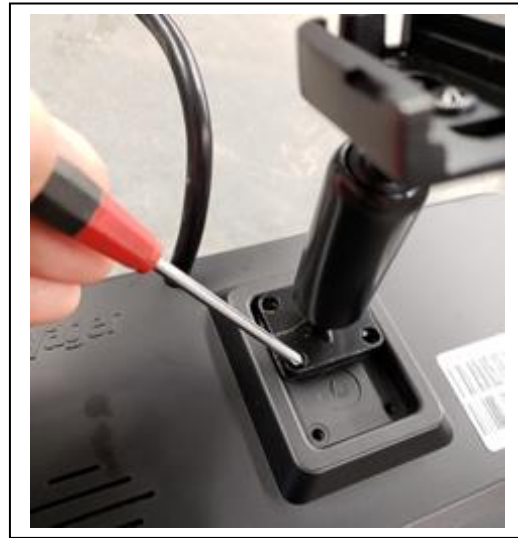
Step 3 - Remove the mirror mount by removing the four screws that hold it. The mount can be saved and used for the new monitor, if needed.

Step 4 - Install the new Revision monitor and reconnect the 13-Pin Connector. Re-install Dome Light Cover

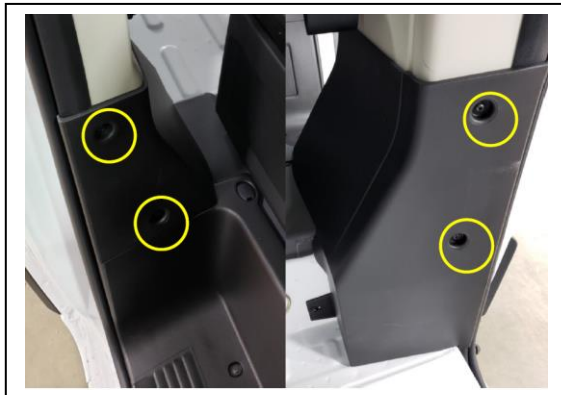
Step 1: Remove B Pillar floor panel on passenger side

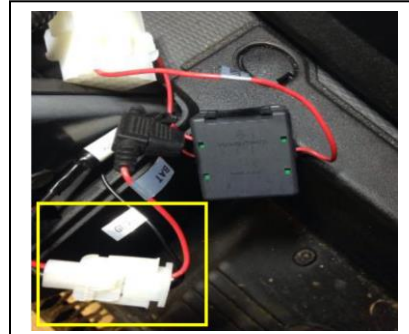
Step 3 – **Connect together** the two 15 pin connectors in vehicle to supply power to monitor
