Department of Transportation FEDERAL MOTOR VEHICLE SAFETY STANDARDS

“The K.T. Safety Act” FMVSS No. 111

ASA Electronics FMVSS No.111 Testing Environment

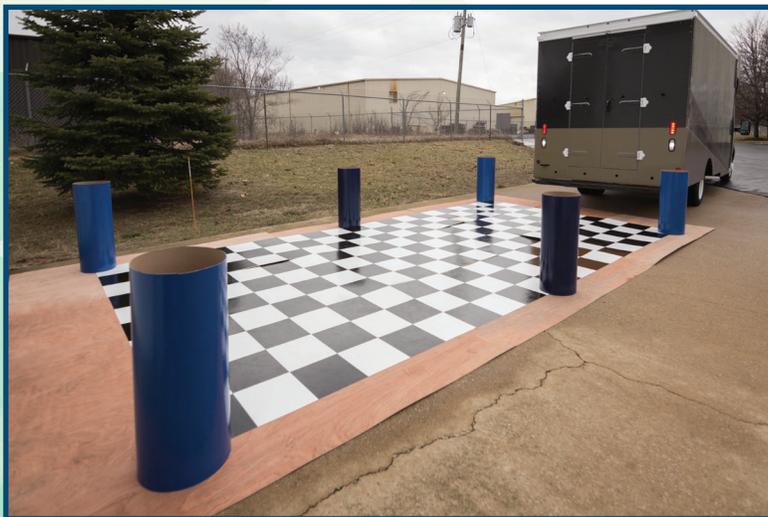
“The K.T. Safety Act” FMVSS No. 111 mandates a field of view test. This test includes “a cylindrical test object with a height of 32 inches and a diameter of 12 inches, consistent with an 18-month-old toddler.”

1. Checkered grid with 1'x1' black and white tiles measuring 10ft wide x 20ft deep.
2. 7 - 32"x12" diameter markers (consistent with an 18-month-old toddler).
3. Voyager® VCMS140i and VCMS155 cameras.

All measured cameras exceeded the test grid view to be able to see the expected camera view coverage per the FMVSS No.111 specifications.

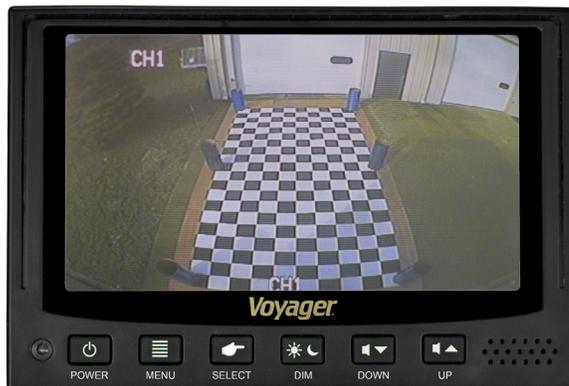
Vehicle Type: Box Truck
Camera Height: 12.5'
Camera Used: VCMS155

Extended Side View Measurements

- 9.6' from first markers
- 16.0' from second markers
- 23.8' from third markers

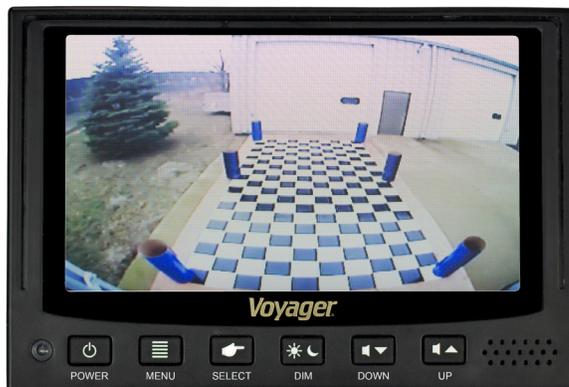
Vehicle Type: Cargo Van
Camera Height: 5.3'
Camera Used: VCMS155

Extended Side View Measurements

- 6.6' from first markers
- 15.6' from second markers
- 25.0' from third markers

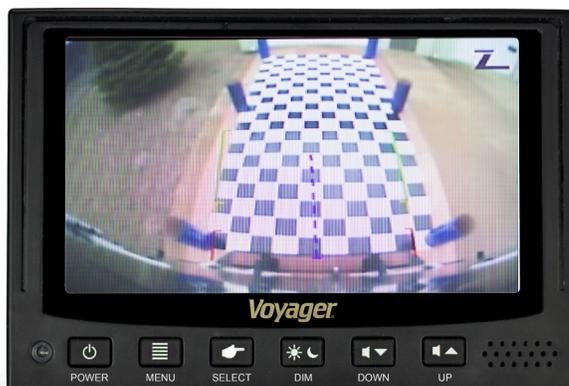
Vehicle Type: Walk-In Van
Camera Height: 9.5'
Camera Used: VCMS140i

Extended Side View Measurements

- 5.3' from first markers
- 16.6' from second markers
- 26.6' from third markers

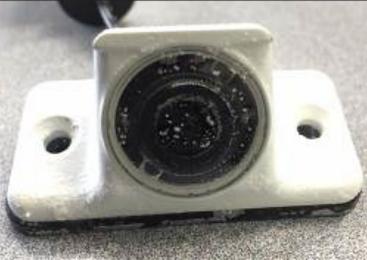
Camera	Test Observations	Results	
VCMS140i	Performed QFog Salt Fog Test on VCMS140i. After 24 hours examined the camera for signs of rust or corrosion due to the testing. Camera showed no signs of rust at 24 hours.	Pass

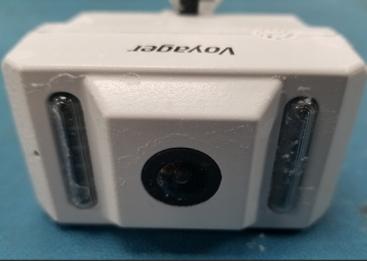
VCMS155	Performed QFog Salt Fog Test on VCMS155. After 24 hours examined the camera for signs of rust or corrosion due to the testing. Camera showed no signs of rust at 24 hours.	Pass

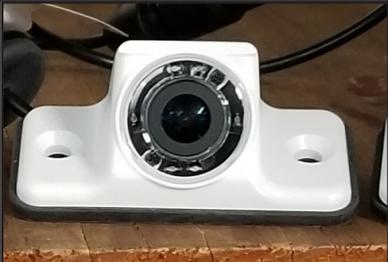
Camera	Test Observations	Results
VCMS140i	Camera was set up in chamber at FMVSS 111 specifications as listed above. Camera was observed during testing and was fully functional throughout the test. Upon test completion, camera remained fully functional.	Pass

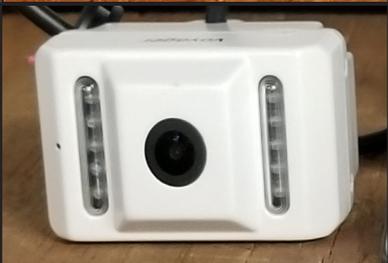
VCMS155	Camera was set up in chamber at FMVSS 111 specifications as listed above. Camera was observed during testing and was fully functional throughout the test. Upon test completion, camera remained fully functional.	Pass

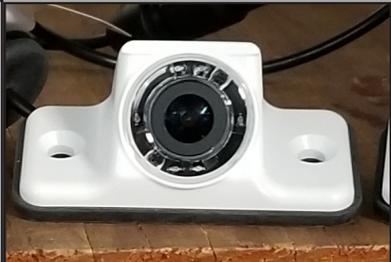
Camera	Test Observations	Results
VCMS140i	Camera was placed in temperature chamber according to FMVSS 111 standards. camera was operational during test and monitored throughout. No abnormalities were noted and following test completion camera remained fully functional.	Pass

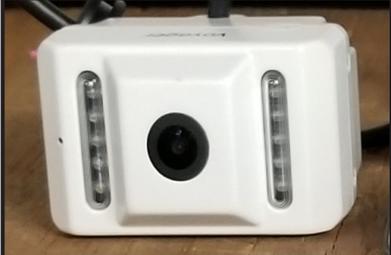
VCMS155	Camera was placed in temperature chamber according to FMVSS 111 standards. camera was operational during test and monitored throughout. No abnormalities were noted and following test completion camera remained fully functional.	Pass
