Sprinter Voyager Mirror Monitor VOM74MM Not Working

Original Release:	3/20/2020	Document Number:	TS-10003CF
Current Revision:	A	Written By:	Alex Peek
Revision Date:		Approved By:	Tim Welling
Description:	Sprinter Voyager Mirror Monitor VOM74MM Not Working

TROUBLESHOOTING

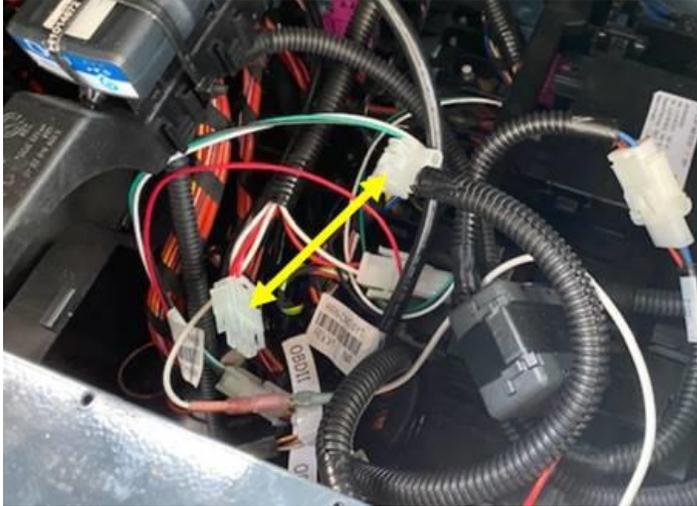
Under Driver Seat

1. The two white 3 pin connectors have to be plugged together.

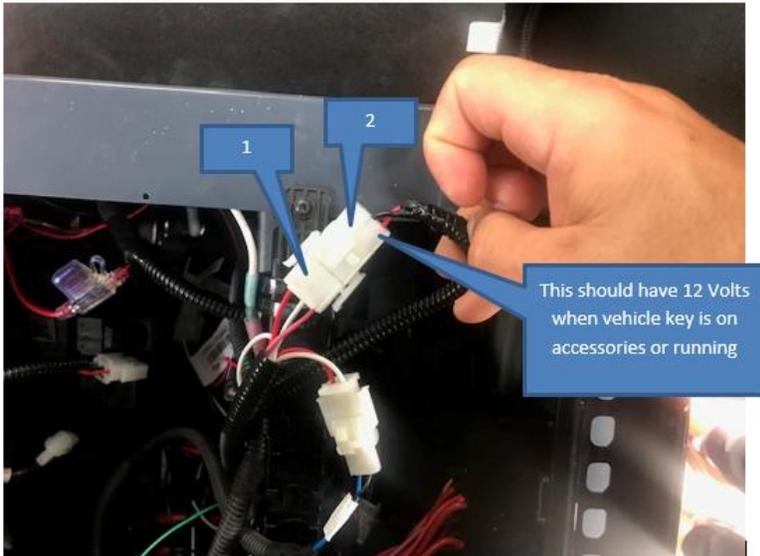
2. These two connectors are shown plugged together.
 - a. Connector "1" has red, white, pink wires (From PSM)
 - b. Connector "2" has red and black wires (powers to monitor)
 - c. NOTE: harness with blue, black, red wires should be out of circuit.

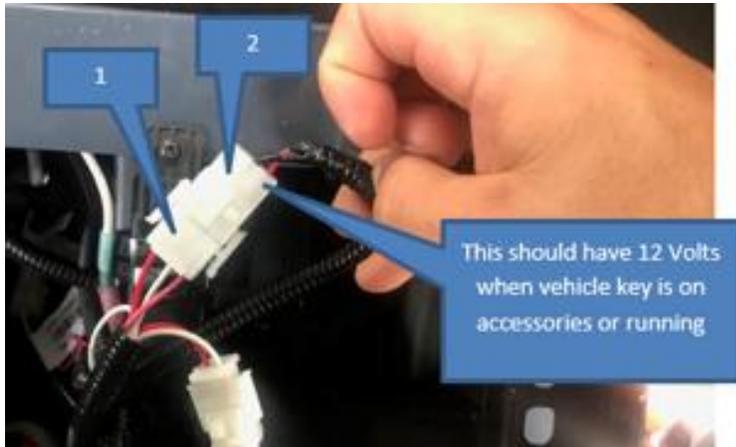
3. The connections into the PSM must be seated well. PSM harness supplies power to Monitor/Camera system. The UTM harness part number is 1651780 (if the harness label says 16517641 it should have been replaced with 1651780). A couple Sprinters needed this harness re-seated into the PSM.
4. 25 AMP Fuses 14 and 15 must be present and good (located at driver seat fuse block)
5. Must have 12V DC power on Pink and White wires of connector 1 below when the key is on accessory and/or vehicle is running.

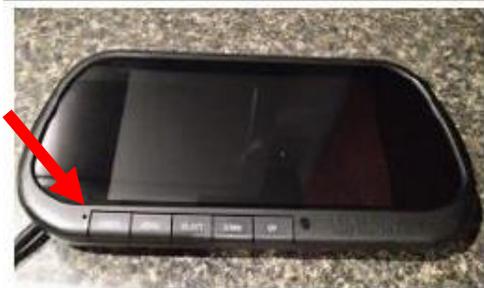
6. If 12V DC is at the connector shown in 5 above, then it could be the connection directly to the monitor above the dome light or the monitor could be defective.

NOTE: If the monitor has power, the indicator to the left of the power button should be Blue when powered ON or Red when powered and in standby mode.

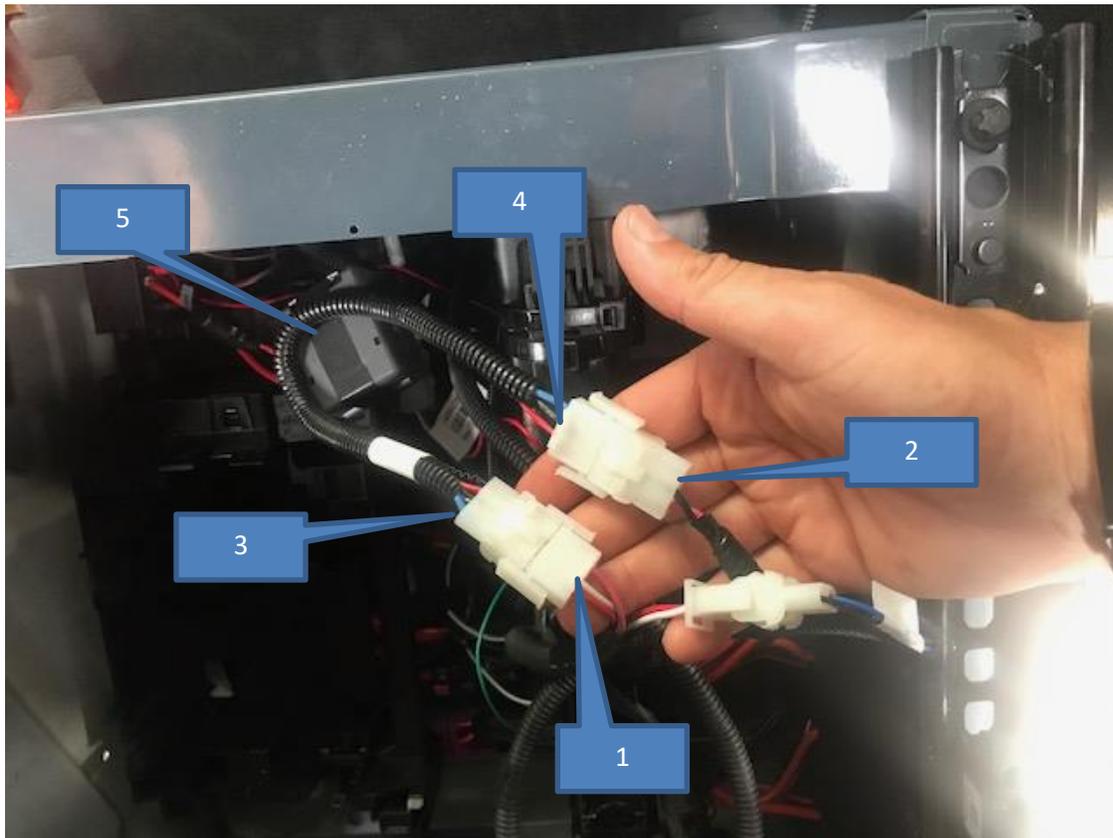
Fix Kit in the circuit under the seat

1. Connector from PSM (Power Supply Module)
2. Connector going to the monitor
3. Connector to field fix kit (remove)
4. Connector from Field fix kit (remove)
5. Field Fix Kit Harness black box (part of the harness that should be removed)

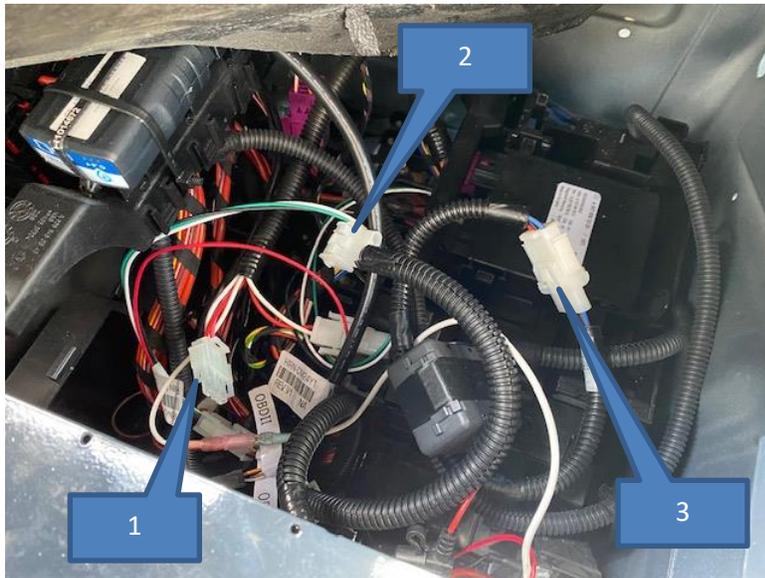
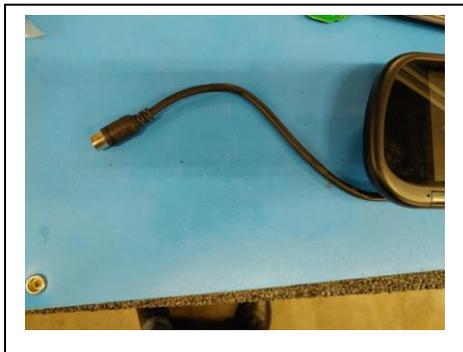
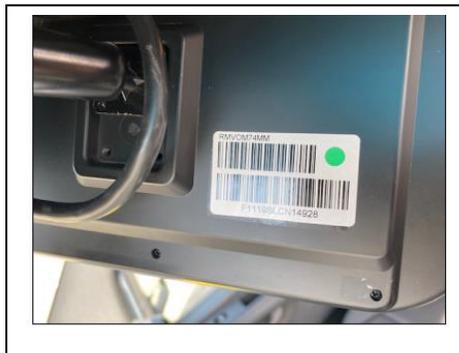
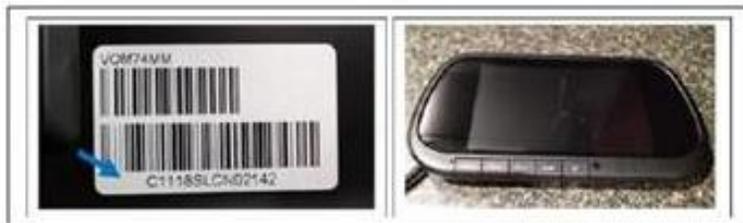
1 and 2 should be plugged together.

3 shown below is the fix kit plugged into itself. This is irrelevant since it is not connected to 1 and 2.
